# Crestwood, IL RLR 3 Year Follow-Up

**Evaluation Report**

Reference No: 016-65548 May 2022

Re: RLR 3 Year Follow-Up Evaluation Report Midlothian Tpke and Cicero Ave – Northbound and Southbound Village of Crestwood Ref #: 016 – 65548

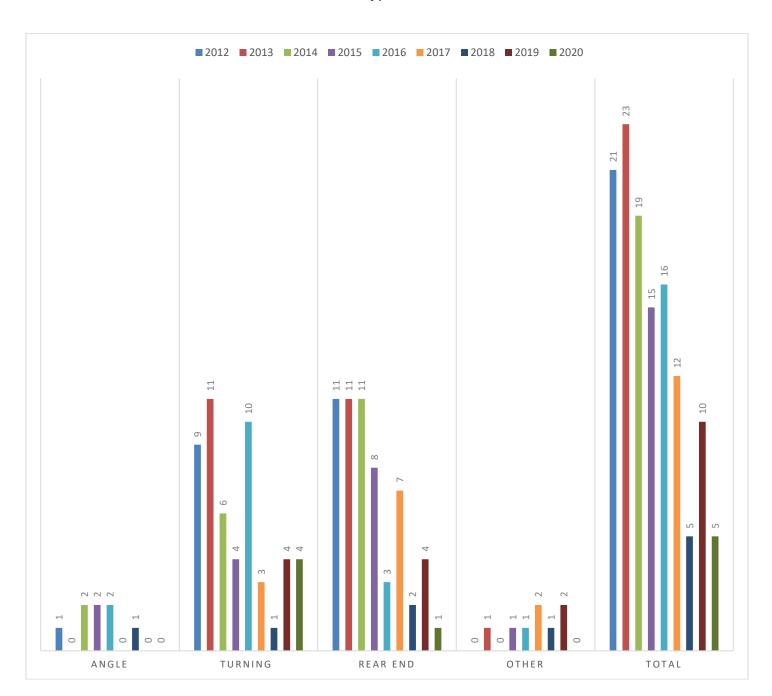
The Chart below shows the trend of each crash type from 2012-2020.

From 2012-2015, prior to RLR camera installation, there were 78 total crashes; this averages out to 19.5 crashes a year.

From 2017-2020, post RLR camera installation, there were 32 total crashes; this averages out to 8 crashes per year - a 58.97% reduction of overall crashes in direct comparison with the time period aforementioned.

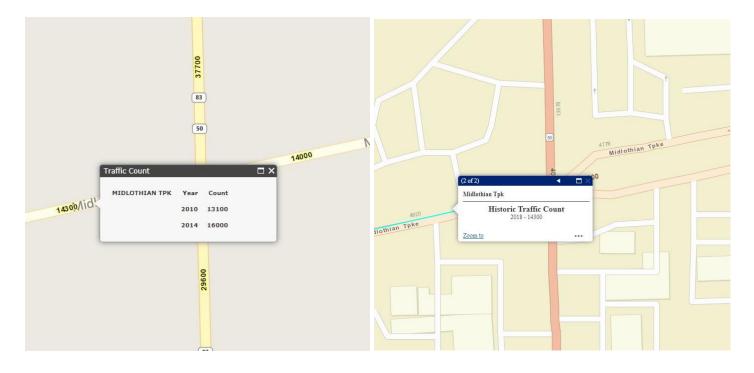
#### Eastbound ADTC

The traffic numbers below were obtained from the IDOT website during the preparation of past reports and now per the RLR Guideline document published by the IDOT. Only ADTC values were available, peak numbers were not provided.

From 2013-2015, prior to RLR camera installation, the combined average of ADTC was 102,500.

From 2017-2020, post RLR camera installation, the combined average of ADTC was 95,425 - a reduction of 6.9%.
