Midlothian Tpke and Cicero Ave

<Northbound and Southbound>

Crestwood, IL RLR Follow-Up

Evaluation Report

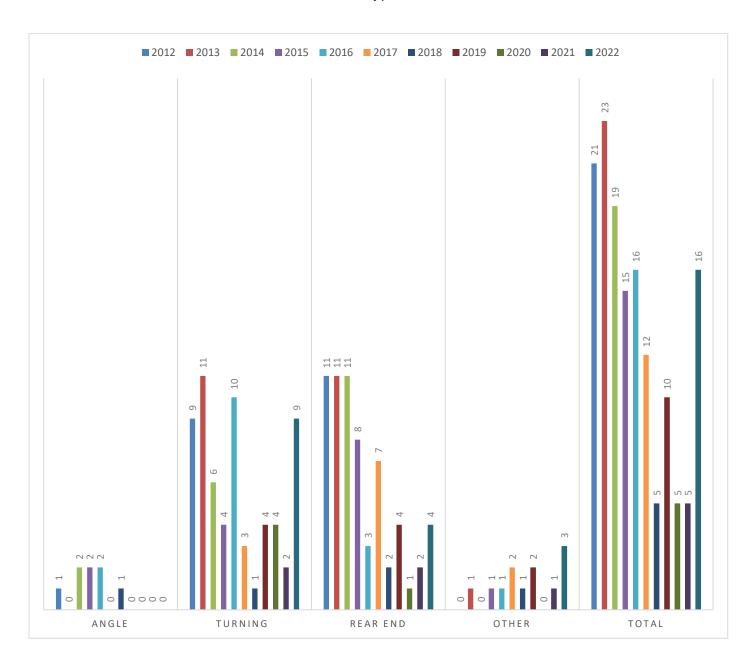
The Chart below shows the trend of each crash type from 2012-2022.

From 2012-2015, prior to RLR camera installation, there were 78 total crashes; this averages out to 19.5 crashes a year.

From 2017-2022, post RLR camera installation, there were 53 total crashes; this averages out to 8.83 crashes per year - a 54.7% reduction of overall crashes in direct comparison with the time period aforementioned.

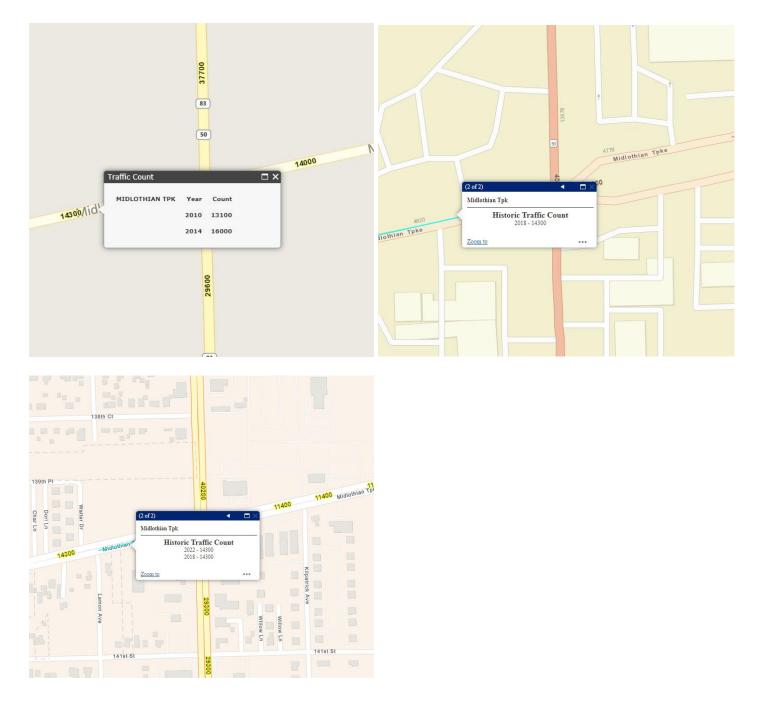
Eastbound ADTC

The following pages show the complete ADTC data from 2013-2022 obtained from the IDOT's website.
