# 135<sup>th</sup> St and Cicero Ave

<Westbound, Northbound and Southbound>

## Crestwood, IL

## RLR Follow-Up Evaluation Report

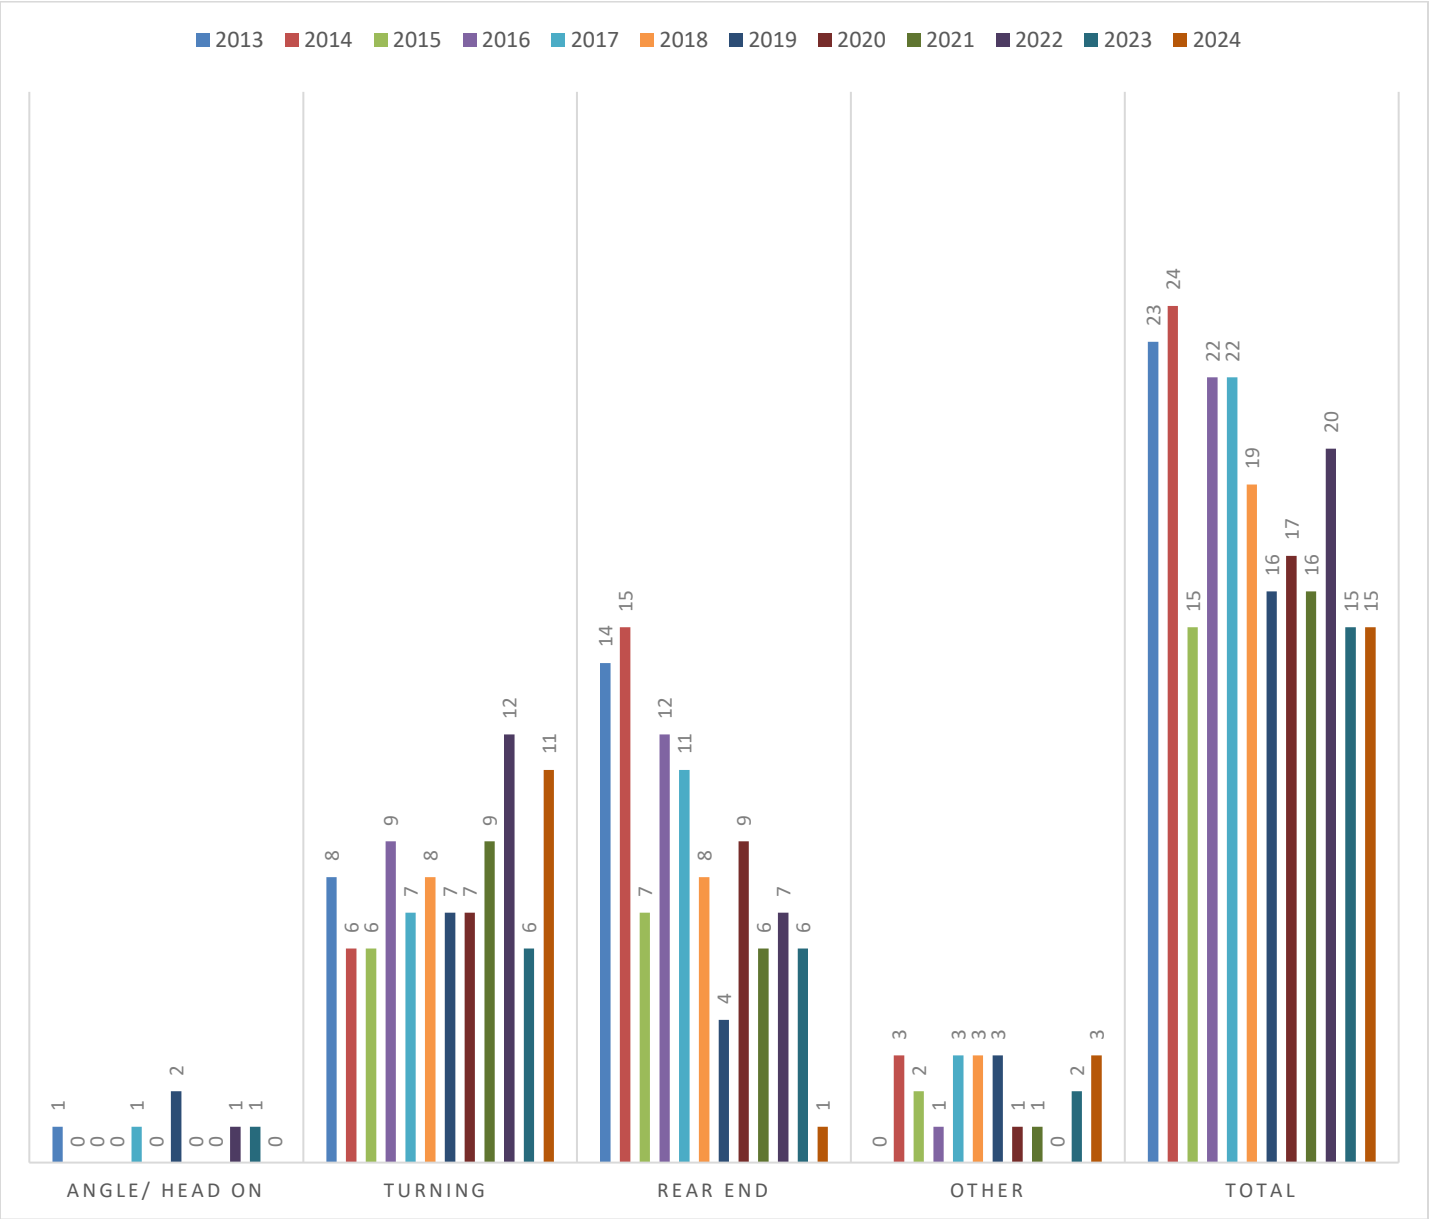
The Chart below shows the trend of each crash type from 2013-2024.

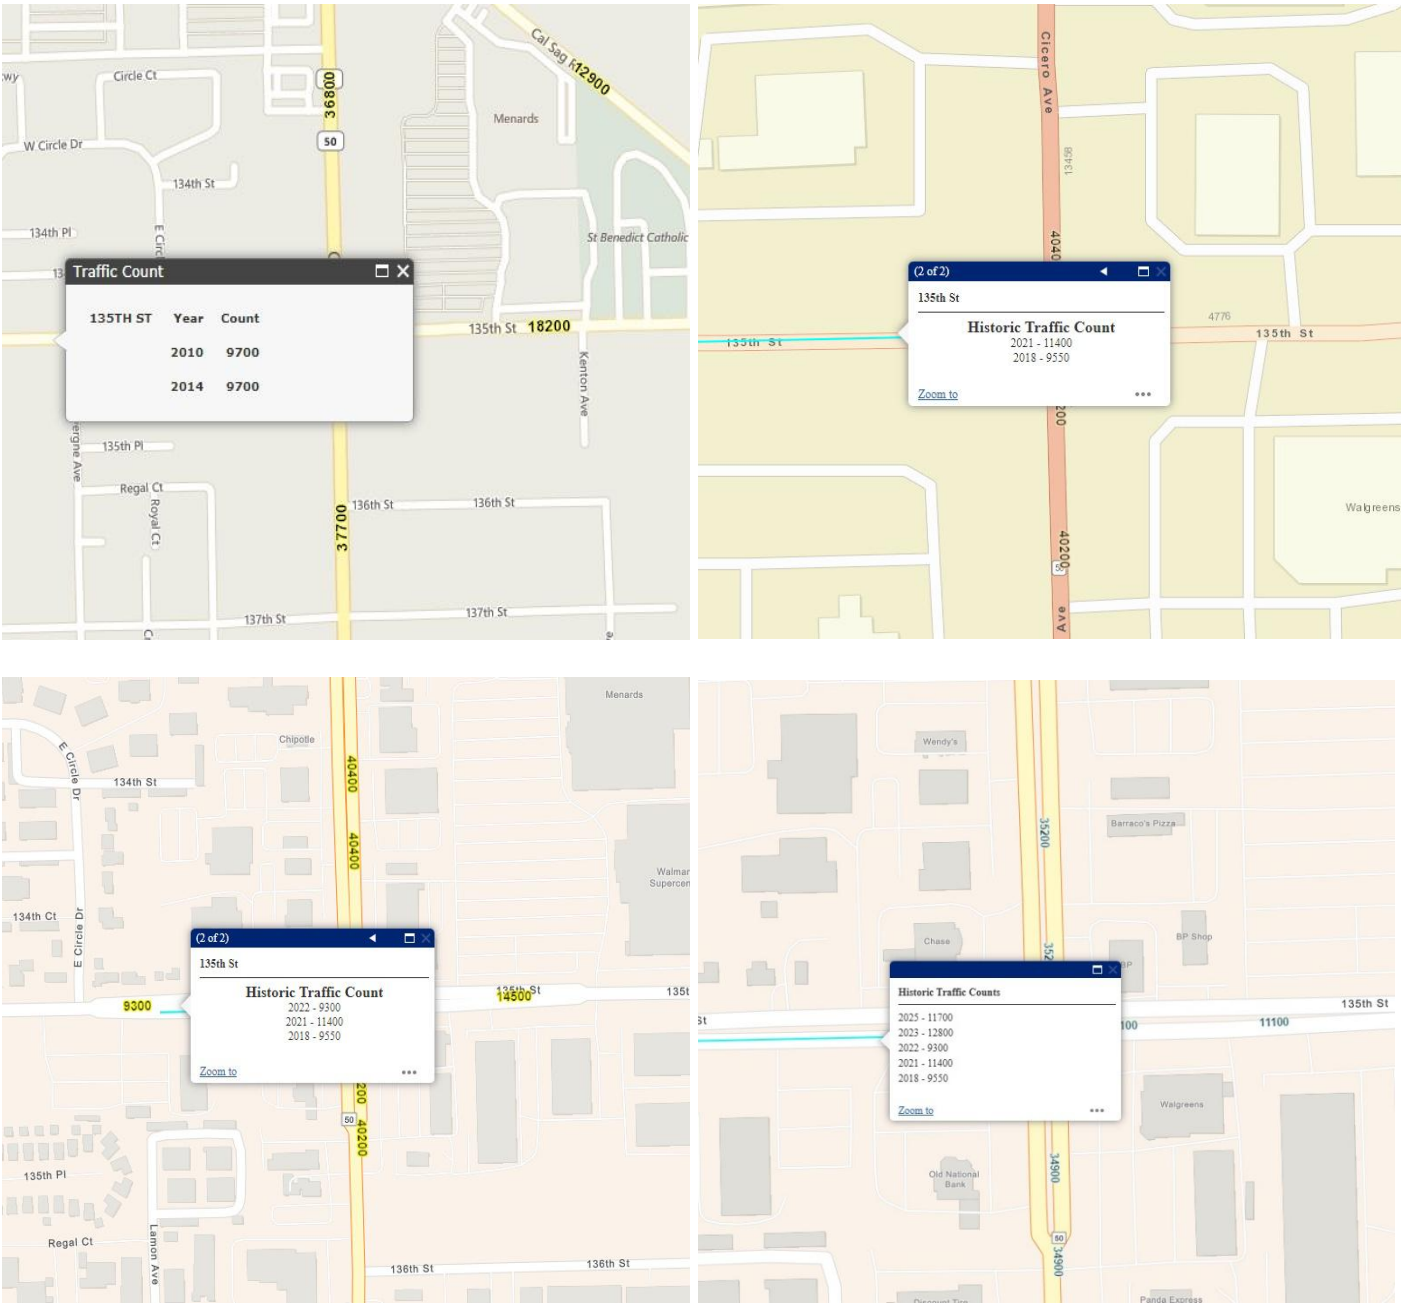
Eastbound ADTC

The traffic numbers below were obtained from the IDOT website during the preparation of past reports and now per the RLR Guideline document published by the IDOT. Only ADTC values were available, peak numbers were not provided.
